# MONUMENT RECORD

Corner ID: **BeBI\_I07**

## Quarter Corner

Sections 8 & 9 –T10N-R02W, 2nd P.M.

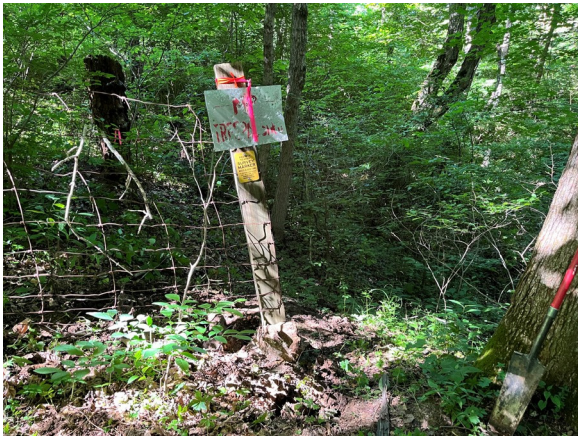
Photo Orientation & Description: From Northeast looking

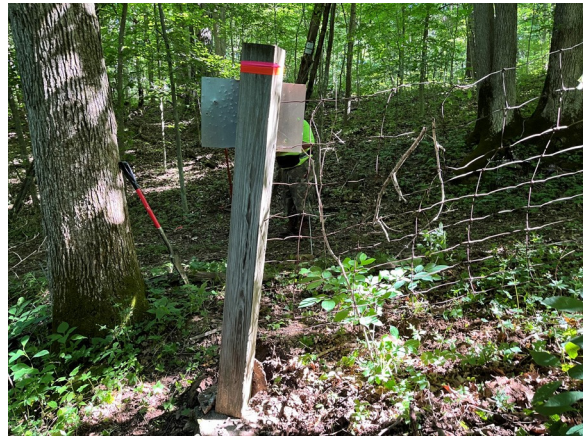
Photo Orientation & Description: From South looking North Southwest
